## Structural Assessment and Restoration of the Leaden Mosque in Berat, Albania

Yavuz YARDIM<sup>1\*</sup>, Enea MUSTAFARAJ<sup>1</sup>

<sup>1</sup>Epoka University, Civil Engineering Department, Tirana, Albania

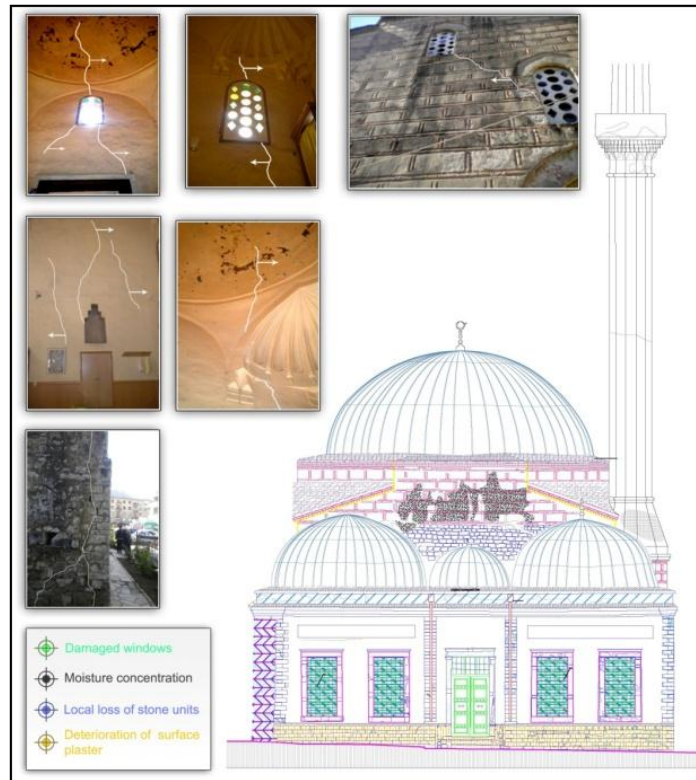
structural and non-structural problems evidenced (Fig.4). The roofing system is seen to be inefficient. Improper isolation enables leakage and penetration of rainwater inside the mosque. Thus, moisture spots and spall of plaster are seen in many regions of the interior.

**Figure 4.** Structural problems in the Leaden Mosque

There are observed structural cracks at the pendentives level, which are thought to have been caused by lateral stresses (earthquakes). Assessment form data are shown in Table 1. From the assessment

results, it is seen that load bearing walls are the ones containing more cracks. A diffuse series of visible cracks are present in all façades of the mosque.

Most of the cracks inferred from the damage survey presented a diagonal and vertical trend. Creep of the masonry units is believed to be the cause of vertical parallel cracks which eventually may lead to collapse of the wall. This phenomenon is accompanied by occurrence of chipping and possible local failure. Propagation of the cracks from pendentives to the load bearing walls is observed in all four facades. In the places where openings are present, a different crack pattern is seen. For instance, the tensile and shear stresses are concentrated close to the edges of these openings possibly due to local concentration of

loadings. Hair-line cracks are seen in the interior of the walls. [4]

The most important concern about the dome is protecting the interior from atmospheric agents like rain and snow. In order to achieve this, the roofing system should be improved. Leaden layer of the cap should be checked for possible misalignment of the layers, and repaired where damaged. The water collecting system should be changed as it is seen to be inappropriate.

Non-structural cracks less than 10 mm wide should be filled with grout or hydraulic mortar injection. Injection mix would seal the cracks, protecting the wall plaster from exposure to water. The injection technique is widely used in restoration projects of historical constructions (Bell tower of Monza, Church of St. Sofia in Padua, Outerio Church, Portugal, etc.). [7]

It is observed that the load bearing walls suffer the most from structural problems. They exhibit both visible surface degradation as well as structural cracks. The intervention procedure consists of reducing the shear and tensile stresses on the walls by adding additional tensile and shear resisting elements where necessary. One of the objectives to be achieved is that connections should be flexible rather than rigid to avoid stress concentrations and guarantee the durability of the structure. [5]

Injection is suggested to be used in areas where non-structural cracks less than 10 mm wide are found. The most useful feature is the increase of continuity of masonry. Furthermore, neither aesthetics nor architectural features of the mosques will be altered when applied.

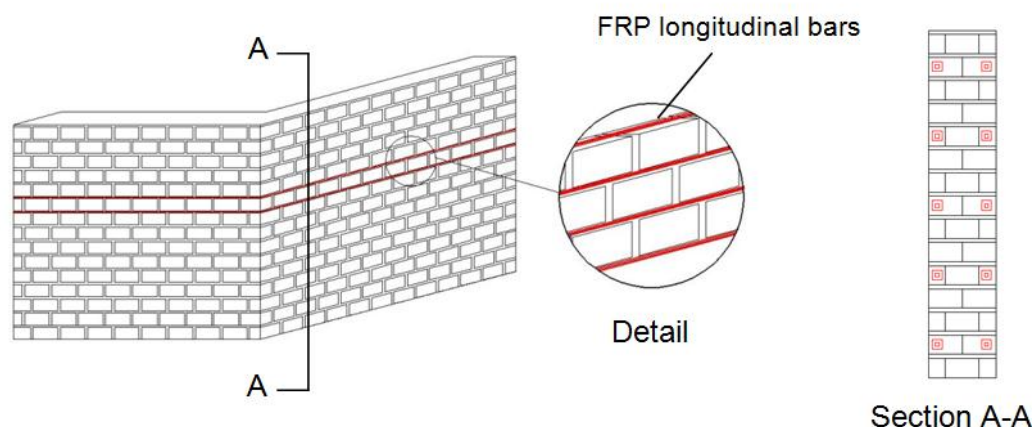
Figure 5. Application of strengthening with FRP bars

The cracks near the openings should be repaired with longitudinal FRP bars bonded with epoxy resin or mortar (Fig.5). This method is based on integration of the high tensile strength properties of FRP into the unreinforced masonry wall and would improve the tensile and shear resistance of the load bearing walls as well as their ductility. The procedure implies insertion of FRP bars about 10 cm inside the wall and refill of the cavity with the same type of mortar. [8]

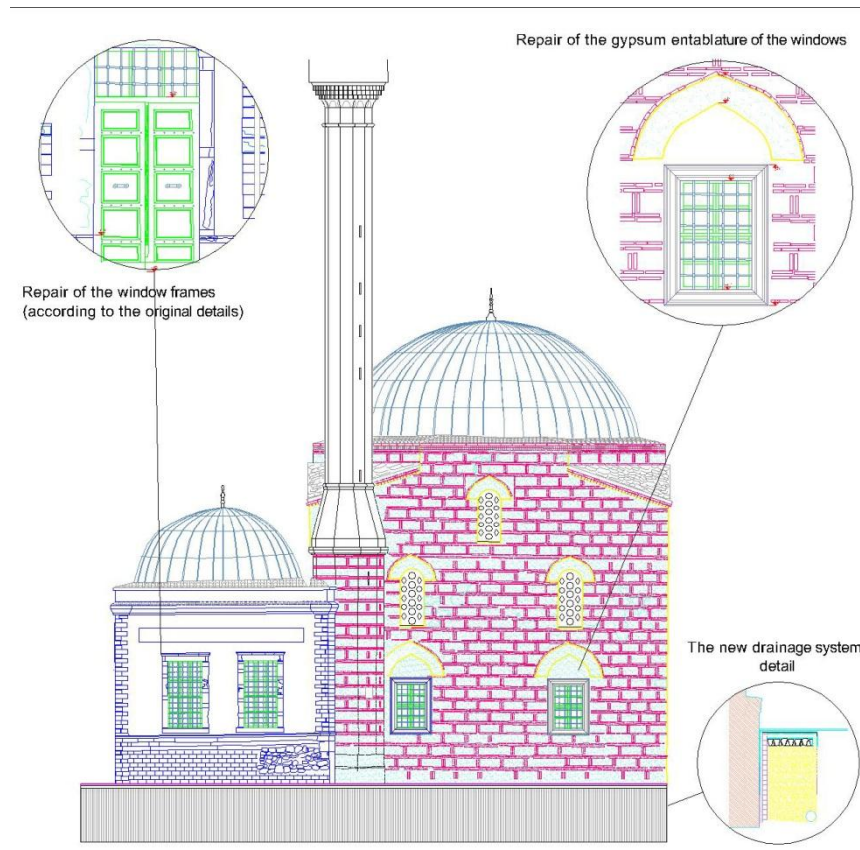
**Figure 6.** The proposed interventions on the west façade.

1. All the original materials and elements of the structure that do not exhibit any deficiency will be kept unchanged.
2. All the missing elements will be replaced with new ones having the same properties.

3. Deformed sections of the leaden cover of the roof should be fixed, and all the cover should be cleaned.
4. Broken tiles should be replaced with original corrugated tiles.

5. Microbiological formations on the stone walls of the façade and in the interior should be removed.
6. Old plaster should be repaired where spall is seen. Khorasan mortar should be used in making the new plaster.

7. Rubble stones of the façade should be cleaned mechanically using salt. Missing stones of the facades should be replaced with new ones which would be prepared using the powder of the original stones bonded with hydraulic lime repairing mortar.

8. Earlier improperly made interventions to repair stones with cement-added mortar, should be removed without damaging the original material.
9. Gypsum entablature of the windows should be repaired, and rotten timber windows should be replaced with new ones that have the same details as the original ones.

10. There should be a detailed check on the walls of the facades which contain discontinuities of building elements like gaps, swelled or cracked regions. Lime mortar should be used to seal those gaps.

11. In order to prevent sanding and to minimize the risk of flood, a new groundwater drainage system should be made around the perimeter of the mosque.
