A Graphical Ontology-Based Method for Rapid Damage Assessment of Stone Cultural Heritage Structures After an Earthquake: A Case Study of Mor Petrus and Mor Paulus Church, Adiyaman/Türkiye

For the proposed method, the heavily damaged Mor Petrus and Mor Pavlus Church in Adiyaman, affected by the earthquakes centered in Kahramanmaraş in 2023, was used as a case study. It is hoped that the presented method will provide guidance to expert teams in determining the temporary emergency intervention needs, planning for repairs, and strengthening structures against seismic risks, thereby resulting in significant time and cost savings.

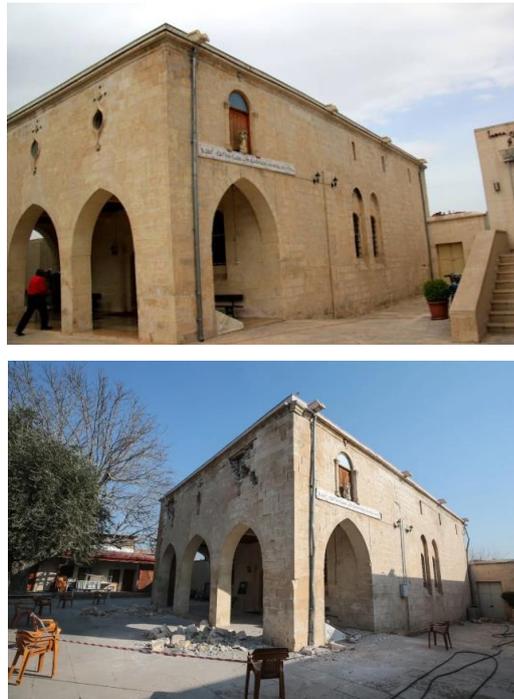
Figure 1. Adiyaman Mor Petrus and Mor Paul Church before (left) and after (right) earthquake (Karataş photo album, 2023)

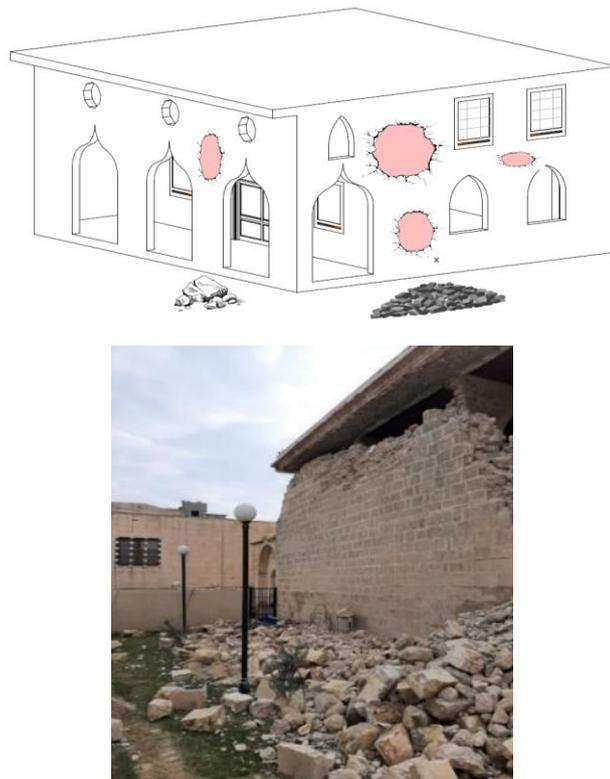
During the field investigations, numerous instances of fragmentation or loss of stone in the wall elements of the structure (2a) were identified. The stone elements of the structure exhibited joint voids resulting from poor maintenance prior to the earthquake, leading to inadequate adhesion between the stones and mortar. Particularly, this condition indicates that the empty spaces formed as a result of voids observed in the vertical joints of the walls, caused by poor maintenance, reduced the out-of-plane bending stiffness of the walls during the earthquake, thereby increasing the extent of damage (Figure 2).

Figure 2. Fragmentation or loss of stone materials in the wall (2a)

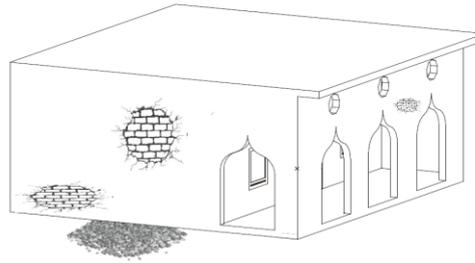
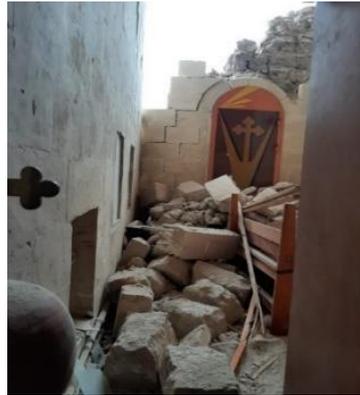
During the field investigations, it was determined that the load-bearing walls of the rubble masonry structure were constructed using a double-walled construction technique with different types of stone materials. Observations revealed a significant amount of pre-earthquake deterioration, primarily due to neglect. In particular, surface damages on the walls were frequently encountered in the worn-out sections. Additionally, due to the use of the double-walled construction technique, the weakened cut stones at the top have separated from the outer cladding, which consists of the less resistant rubble stones. The combination of different types of materials, such as rubble stones and cut stones, along

with the wear and tear the structure has undergone over the years, has led to insufficient adhesion within the wall structure. As a result, the differential behavior of the materials on the inner and outer surfaces of the walls has caused extensive damage (Figure 3).

Figure 3. Weathering of the surface coating (2b), especially in double-walled stone walls

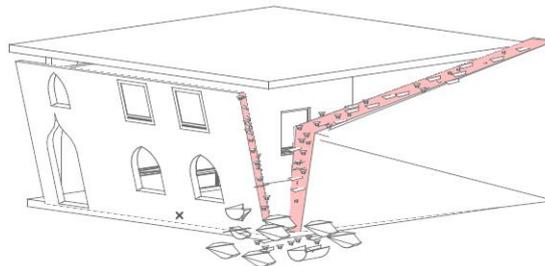
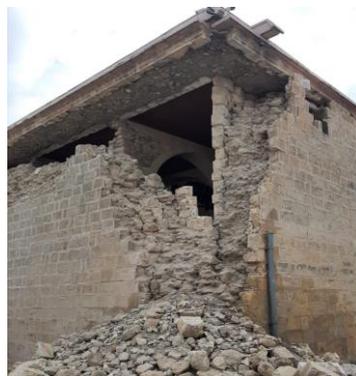
The separation of perpendicular walls with weakened adhesion due to neglect and the use of different types of materials, such as rubble stones and cut stones, has resulted in collapse (Figure 4). The main cause of this type of damage is generally attributed to the tensile stresses generated when the tensile strength of the walls is exceeded (Giuffrida & Deodatis, 2013; Speranza, 2019; Galán-Marín et al., 2020).

Figure 4. The damage observed between perpendicular walls due to the use of different materials or inadequate connections (2c)

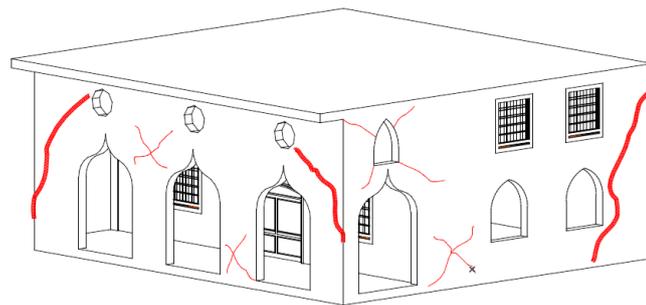
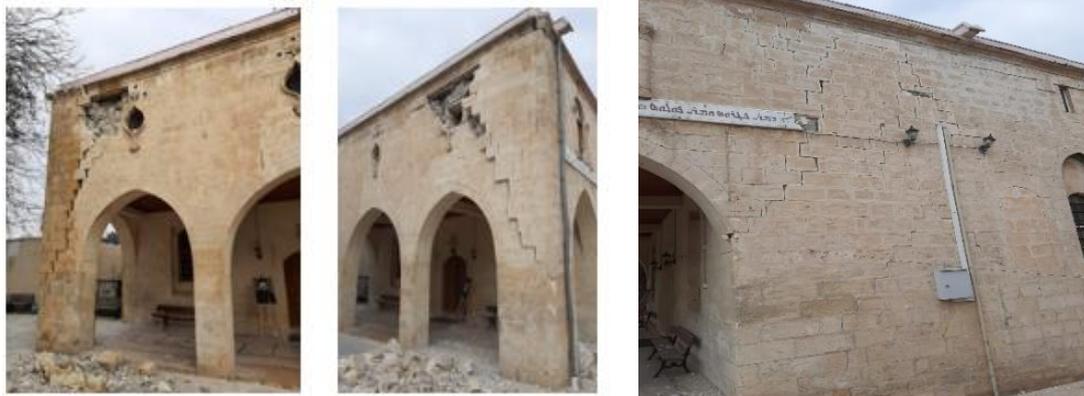
During the field investigations, numerous instances of diagonal shear damage were identified in the wall elements of the structure. The stone elements of the structure exhibited joint voids resulting from poor maintenance prior to the earthquake, leading to inadequate adhesion between the stones and mortar. In particular, the empty spaces formed as a result of voids observed in the vertical joints of the walls, during the earthquake, reduced the out-of-plane bending stiffness of the walls, resulting in increased damage. Prior to the decrease in lateral resistance during the earthquake, characteristic diagonal cracks, also known as diagonal tensile damage, form in the walls. These diagonal cracks can propagate along the joints or directly affect the masonry units, or both. In rubble masonry walls, shear-in-plane damage is common, and when this type of damage occurs in an X shape, it is referred to as double diagonal shear cracks (Figure 5). No in-plane sliding cracks were observed in the main body of the walls.

Figure 5. Shear cracks in the facade wall (2e)

When collapse and out-of-plane damage are prevented, shear cracks in the walls can be reinforced with wooden grids and bands. Especially for supporting structural elements in the field, wood elements or metal profiles, strips, or cables can be used and should be performed by firefighting personnel. More complex applications, such as the use of stabilizing grout, should involve the participation of expert teams (Modena et al., 2011).

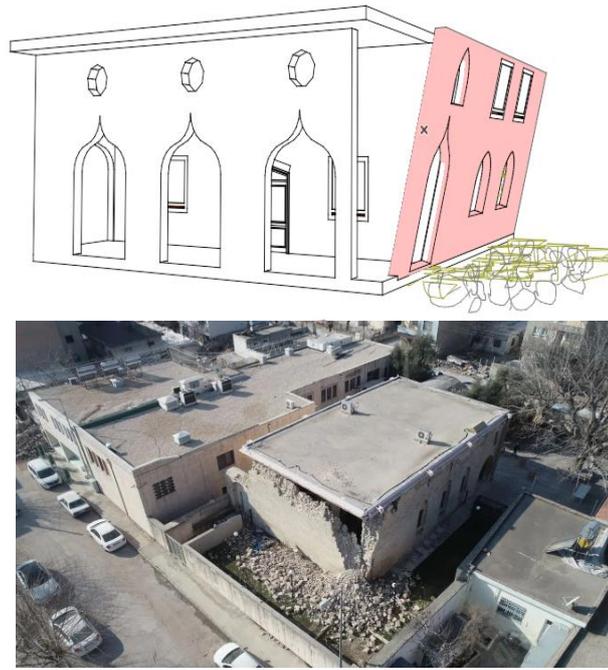
During the post-earthquake damage assessment conducted in the earthquake-affected region, bending damage was also identified in some of the load-bearing walls of the masonry structure. Due to increased lateral forces or displacement demands, the lower sections of the masonry panels experience tensile cracks, and until crushing occurs in the compression zone at the base, overturning is detected due to lack of rotational restraint (Figure 6).

In masonry structures, when vertical loading and axial compressive stresses are within normal limits, a wall will collapse either by shear failure or by bending. Shear collapse occurs when the principal tensile stress in the wall exceeds the tensile strength, resulting from combinations of vertical and horizontal loads (Gülkan & Türker, 2012; Lourenço & Roca, 2006).

Figure 6. The out-of-plane overturning of the entire wall or a portion of it (2f)

Alternatively, where feasible, connecting sections or even entire buildings can effectively prevent out-of-plane overturning. For this purpose, steel cables or more modern polyester straps can be used. Bands and cables connect orthogonal walls to each other and facilitate the distribution of loads from orthogonal walls to parallel walls in the direction of lateral seismic forces. From a logistical standpoint, they allow for the preservation of accessibility around the building. Additionally, they are both practical and can be removed more quickly compared to traditional supports (Karataş & Bayhan, 2023; Caglar et al., 2023).

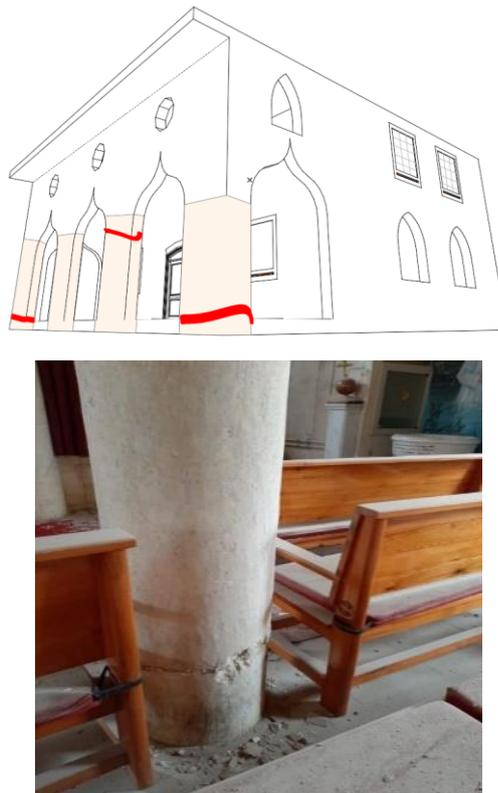
In the Figure 7, the shear failure observed at the column bases is primarily caused by the shear stress resulting from exceeding the tensile strength of the structural element (Figure 7).

Figure 7. In the column bases, in-plane sliding cracks (3a) are observed

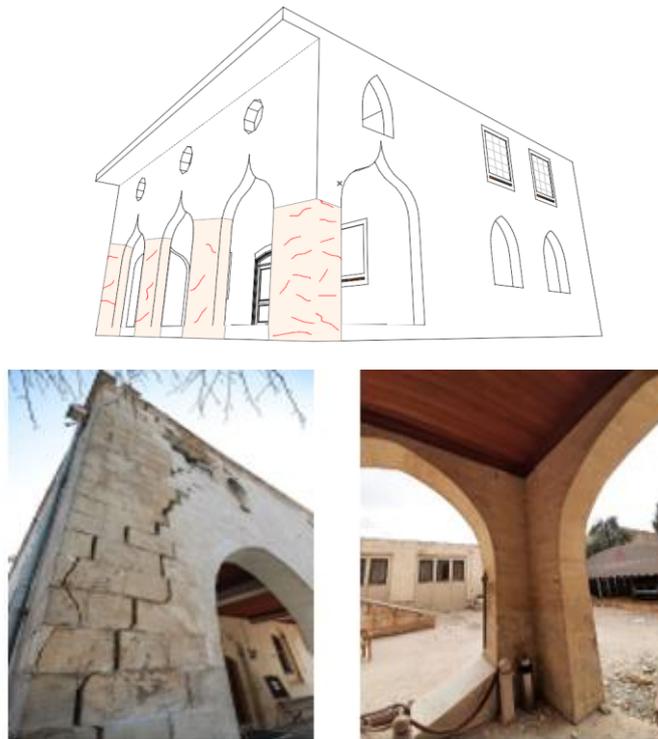
Additionally, improper material connections or material deterioration over the years due to neglect in maintenance lead to structural elements being more vulnerable to horizontal loads from earthquakes (Figure 8).

Figure 8. In the column bases, in-plane torsion or shear cracks (3b) are observed

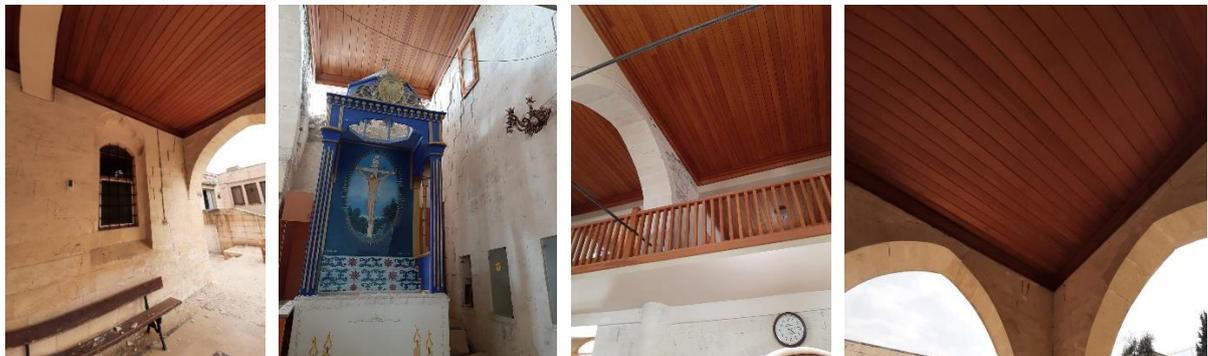
No damage was found in the intermediate floorings, wall corners, or on top of the main wall caused by the roof (Figure 9).

Figure 9. Example images of intermediate floor surfaces after an earthquake

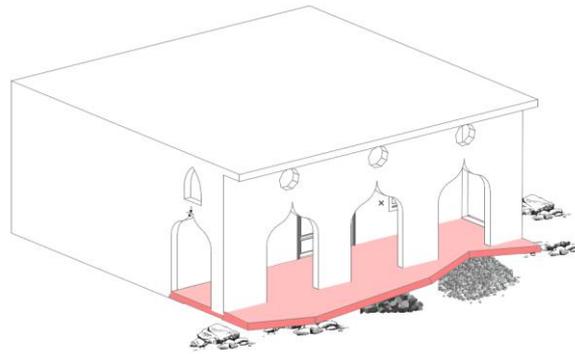
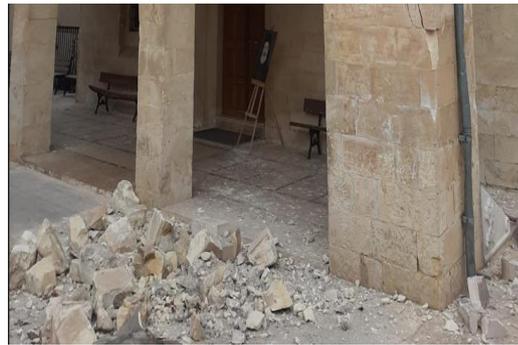
However, it has been determined that there is fragmentation and loss of pieces in the ground floor surface of the structure where it comes into contact with the ground soil, due to various heavy parts falling from the structure (Figure 10).

Figure 10. Fragmentation and loss of pieces (4a)

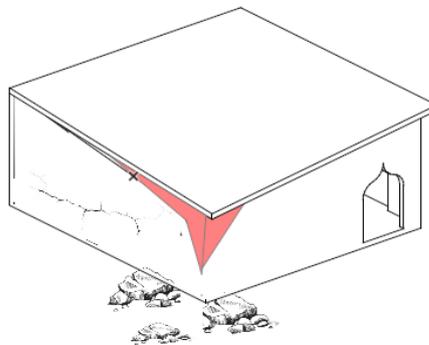
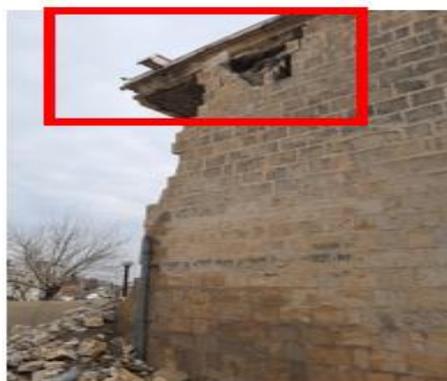
Damage caused by the roof is observed on top of the structural wall and at the corners of the walls (Figure 11).

Figure 11. Damage caused by the roof at wall corners or on top of the wall (6a); Shear damage between the roof and the walls (6b), particularly due to inadequate reinforcement interventions in the past or lack of maintenance

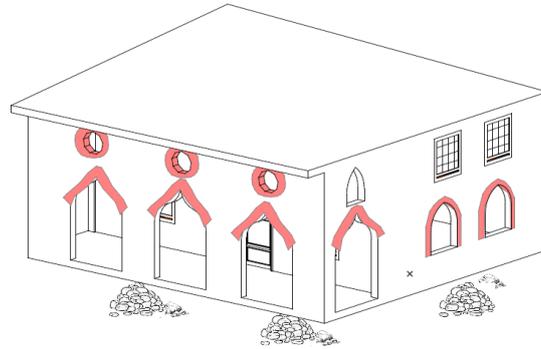
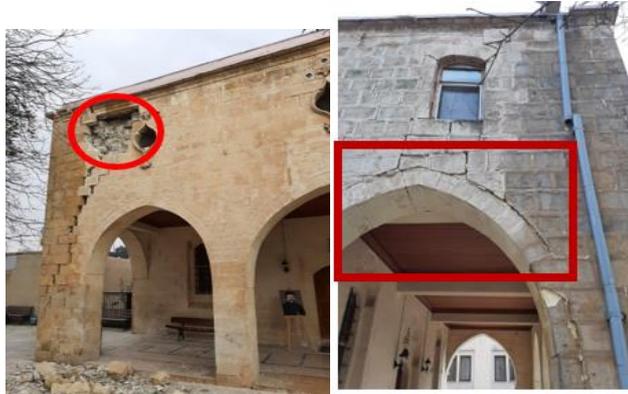
In the structure, it has been determined that inadequate reinforcement interventions in the past or the weakening of material strength due to lack of maintenance have resulted in damage to some decorative elements, such as flaking or loss of parts (2a), caused by the effects of the earthquake (Figure 12).

Figure 12. Damage caused by flaking or loss of parts (2a) in the element; particularly resulting from past insufficient reinforcement interventions or weakening of material strength due to lack of maintenance, and occurred during the earthquake
