A Graphical Ontology-Based Method for Rapid Damage Assessment of Stone Cultural Heritage Structures After an Earthquake: A Case Study of Mor Petrus and Mor Paulus Church, Adiyaman/Türkiye

For the proposed method, the heavily damaged Mor Petrus and Mor Pavlus Church in Adiyaman, affected by the earthquakes centered in Kahramanmaraş in 2023, was used as a case study. It is hoped that the presented method will provide guidance to expert teams in determining the temporary emergency intervention needs, planning for repairs, and strengthening structures against seismic risks, thereby resulting in significant time and cost savings.

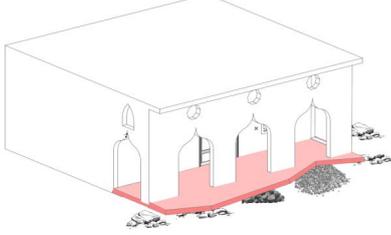
<p>(4) Slabs</p>	<p>Deterioration or loss of stone layer in the slab.</p>

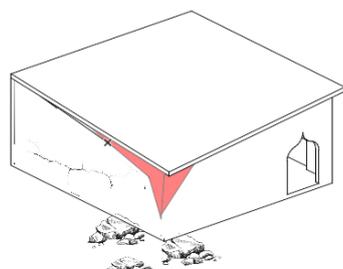
<p style="text-align: right;">+</p>
<p>(5) Roof (Vault, dome, flat roof)</p>	<p>Damage caused by the roof at wall corners or on top of the main wall (5a);</p>
