Wastewater Problems of Adıyaman City and Probable Effects of Them on Atatürk Dam Lake

Mehmet ÇEKIM^{1*}, Sayiter YILDIZ²

Adıyaman Kenti Atıksu Problemleri ve Atatürk Baraj Gölü Üzerindeki Olası Etkileri

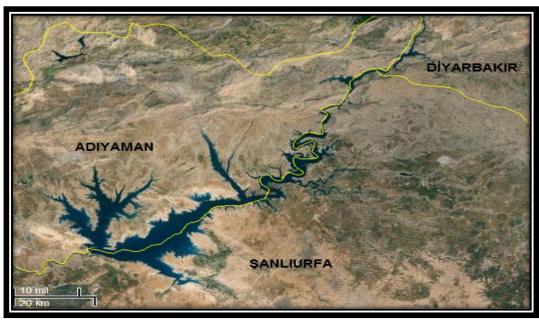
Figure 1. Satellite image of the Atatürk Dam Lake and surrounding provinces (GIS, 2013)

With its length of 180 km, volume of 48.7 km³ and surface area of 817 km², the Atatürk Dam Lake is Turkey's largest lake after the Van Lake and the Salt Lake (Alhas, 2007). There are 3 provinces, 10 counties and 156 villages surrounding the Atatürk Dam Lake (Figure 1) (Gönüllü, 2010). This dam is the biggest dam in our country in all aspects. Additionally, it is the fourth biggest dam in terms of dam volume, and the ninth in terms of water volume in the world (Duman and Çelik, 2001). Furthermore it is among the top 30 dams in terms of energy production and lake volume (Alıcı, 2012).

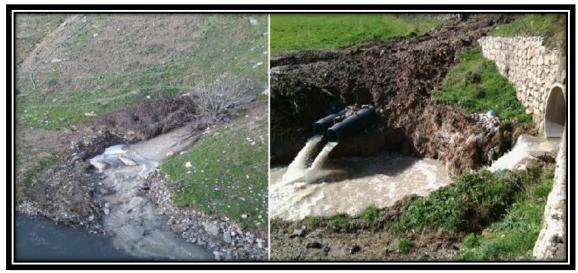
Domestic waste waters discharged to the Eğri River from 4 different points (from 2 different points under the Eğri River bridge and from 200 m north of this point and the point where Altınşehir waste waters meet Eğri River) and to the Sitilce River from 5 different points (from the west of the Open Prison, 150 m south of the Old Cemetery, exit of the Old Slaughter House, The Vartana Road Bridge, and the east of the Provincial Special Administration). Wastewaters given to the receiving environment reach the Atatürk Dam Lake via two different arms (the Eğri River and the Sitilce River). Discharge of domestic sewage system to the Eğri River is shown in Figure 2.

Figure 2. A view of domestic waste waters discharged to the Eğri River

Adıyaman is the second prioritized dirty province in terms of water pollution. The lack of a wastewater treatment plant and regular landfill area affect the water quality of Eğri River and the Atatürk Dam Lake negatively. the Municipality of Therefore, both Adıyaman and the OSB Regional Directorate must immediately construct the wastewater treatment plants and operate them as soon as possible.

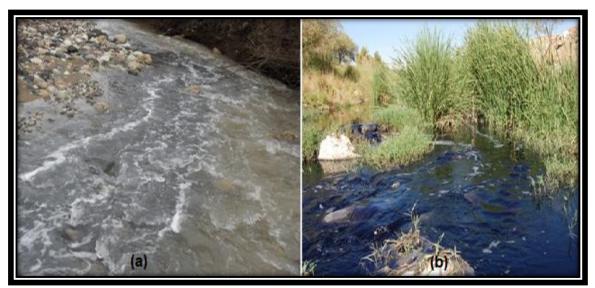
villages were visited as part of this research. Accordingly, it was observed that the Eğri River was flowing in a dark color till it mixes with the dam lake. Village inhabitants stated that they did

not use the Eğri River for watering and that it harmed the animals. Furthermore, many people stated that the rushes and wounds on their hands were caused by the water of the Eğri River.

Figure 3. (a) A view of the Eğri River in the rainy season (b) A view of the Eğri River in the dry season

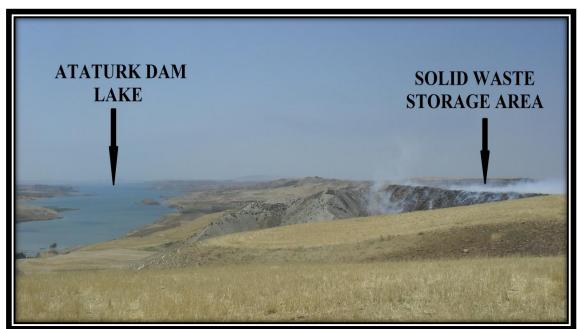
areas and road sides in the province (Figure 4) (Adıyaman Governorship, 2013).

It is estimated that 160 tons of domestic waste is disposed off in Adıyaman city center per day. These wastes are collected by the municipality and stored in a location approximately 1000 meters far from the Atatürk Dam Lake (Gönüllü, 2010). Solid waste landfill area leachates in the province are also reaching the dam lake through the river bed. Being poured to the surface water resources, agricultural lands and

Figure 4. The landfill situated in the north of the Atatürk Dam Lake

the Atatürk Dam Lake in the area, garbage leachates which have considerably high pollution values cause an important environmental pollution (Alıcı, 2012).
